# **SERVICE BULLETIN 01/13**

**Publication Ref. Number: 116**

Inspection of Burner frame centre tube

Ultramagic BMK-050 and MK-21 burners, in either triple or quadruple assemblies, fitted with Centre Gimbal Block P/N CR-22-2500.

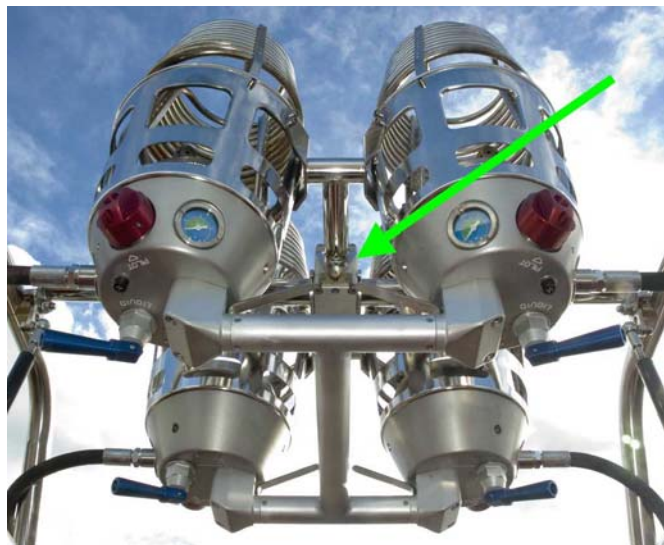
*Figure 1 – MK-21 with Centre Gimbal block system*

Figure 1 below shows an example of MK21 quadruple burner fitted with centre gimbal block (pointed with arrow for easier identification):

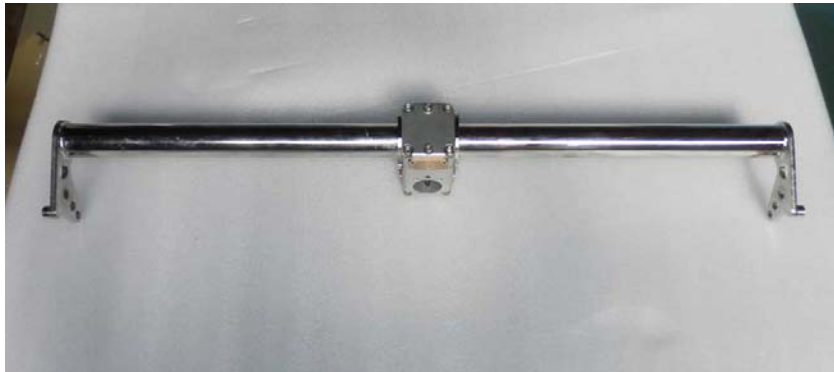
*Figure 2 – Triple Burner support tube with gimbal block assembled*

The crack occurred in the middle of the tube, beneath the centre gimbal bottom cap.

Inspect the condition of the burner frame centre tube (Figure 2) beneath the centre gimbal bottom cap before the next flight.
