ALERT SERVICE BULLETIN

SB No.: 01/24 - Initial Issue
Title: Incorrect webbing on Occupant's Restraint Harness

Issue Date: 16 April 2024
Publication Ref. 218

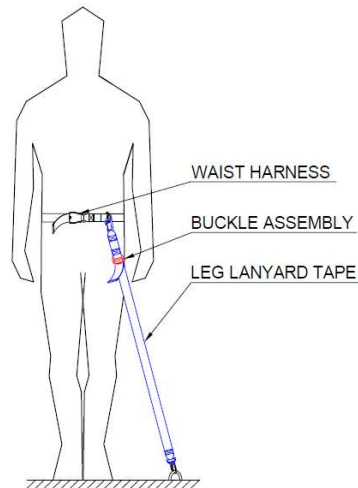
CI-C-1302 Occupant's restraint harnesses where the safety tape has been incorrectly routed/sewn to the adjustment Buckle of the Leg Lanyard (See Figure 1 & Appendix 1)

Description of the restraint harness elements involved (marked blue and red)

A number of restraint harnesses have been identified to mount the buckle for leg lanyard length adjustment in an incorrect way, where the safety tape used has been routed and sewn so that the buckle is not acting in the expected position. As a result, the nominal friction applied by the buckle to the tape is reduced, and the assembly may suffer an unexpected extension when loaded.

- 1) Ultramagic must be contacted, preferably using the form in Appendix 4 of this SB.
- 2) The leg lanyard tape of all affected harnesses must be **identified** and **replaced** with P/N CI-C-1308. This must take place **prior to the next flight** unless action (3) below is adopted.

Such replacement consists in the removal of the lanyard tape by undoing the quick link securing the tape to the restraint attachment point and installing the replacement harness (CI-C-1308) instead. Quick link must then be closed with a 9mm spanner, preferably adding first a drop of Loctite® 638 to the fillet.

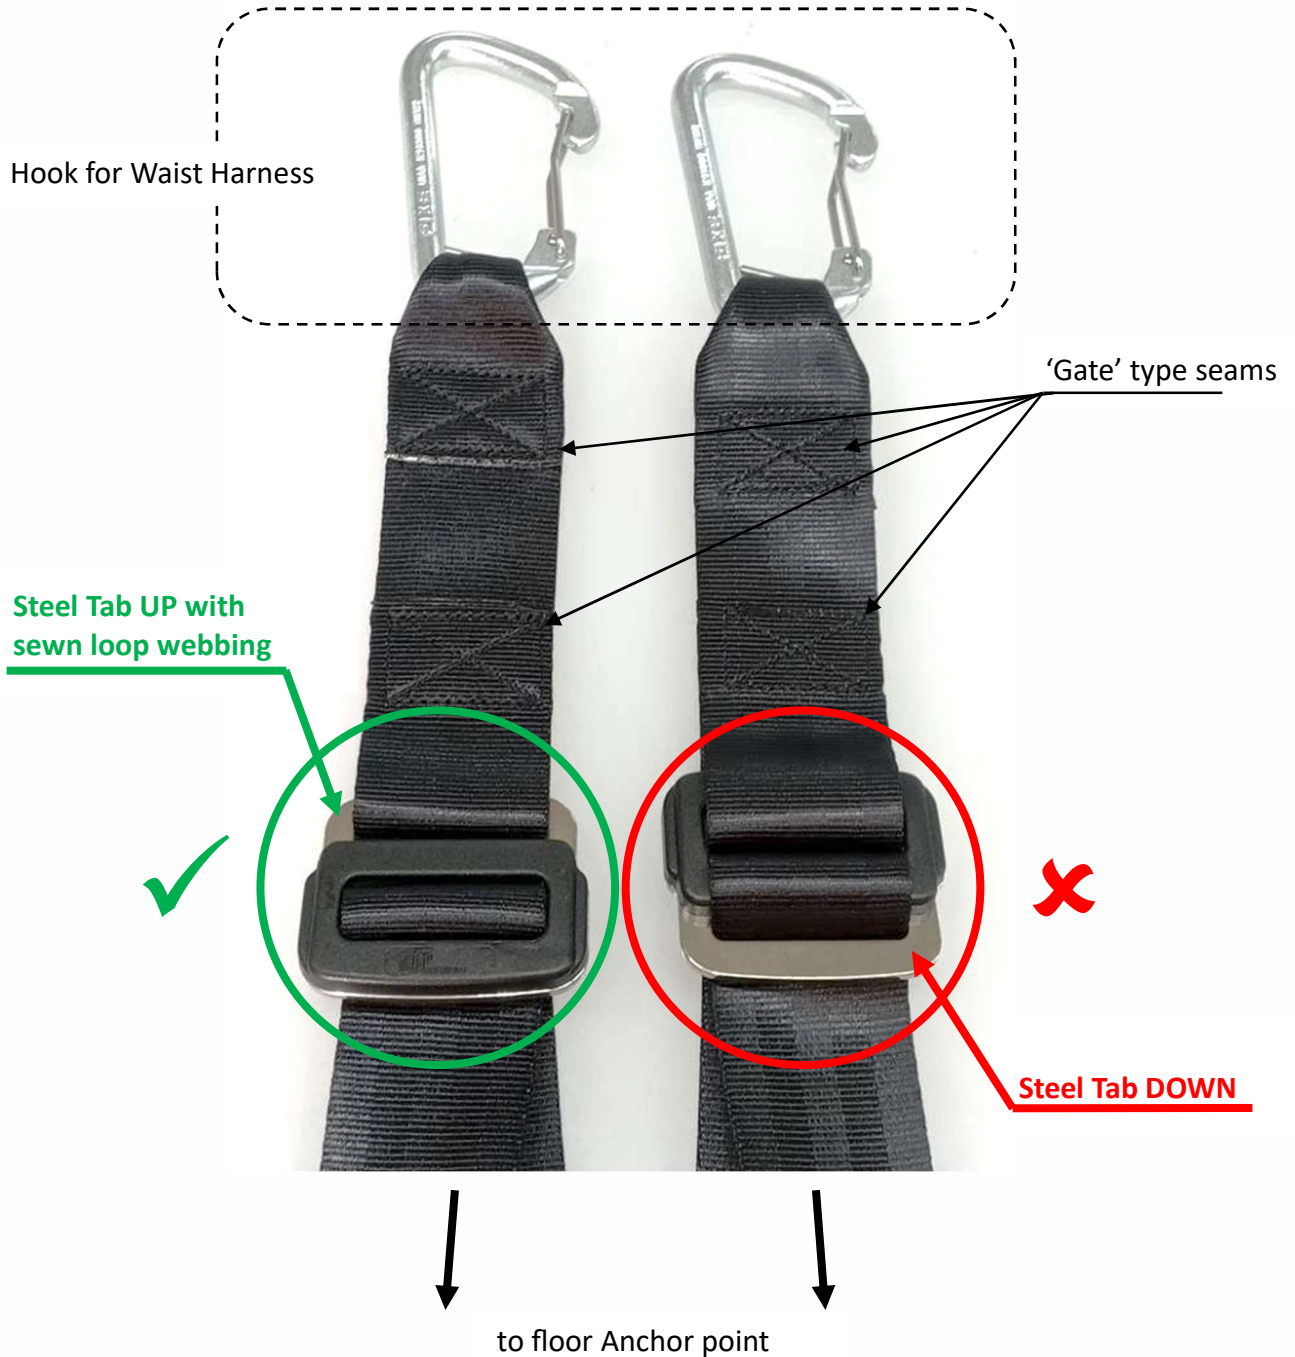
APPENDIX 1 to SB01/24

Example of a correct VS incorrect assembly

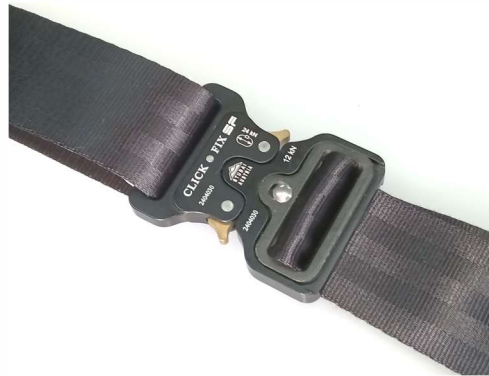
- a) Harnesses using former Stubai type buckle on the Waist Harness

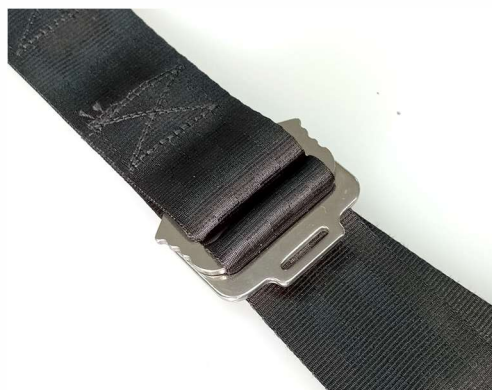
- b) Harnesses using the former full Stainless-Steel buckle on the leg lanyard tape
